Manhole Inspection Summary

Manhole # S2701_001MH

Location Address: **3295 English Consul Avenue** Cross Street: **Magnolia Avenue**

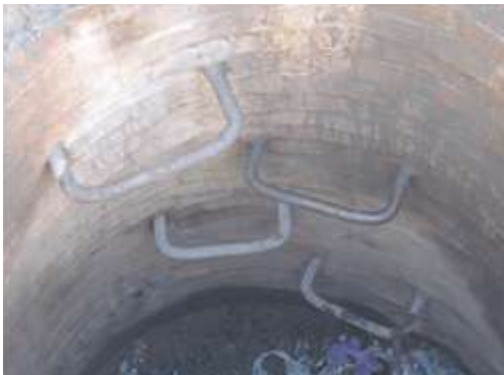
Steps Count: **4** Missing: **0** ☐ Corroded

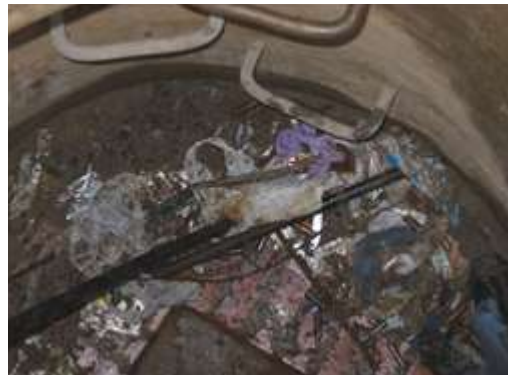
Defect 2

Condition: ☐ Sound ☐ Cracked ☐ Root Intrusion ☐ Deteriorated ☐ Leaks ☒ Debris

Trash

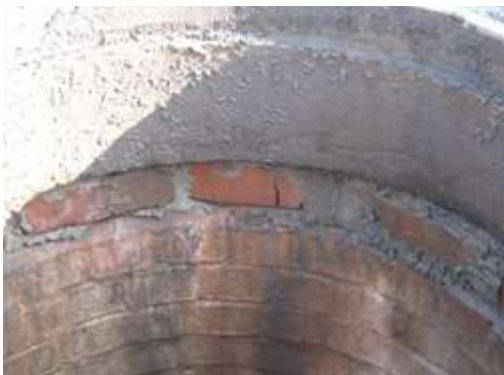
Defect 1

Infiltration: ☐ None ☐ Joint ☒ Cracks ☒ Mortar ☐ Roots ☐ Wall

Infiltration

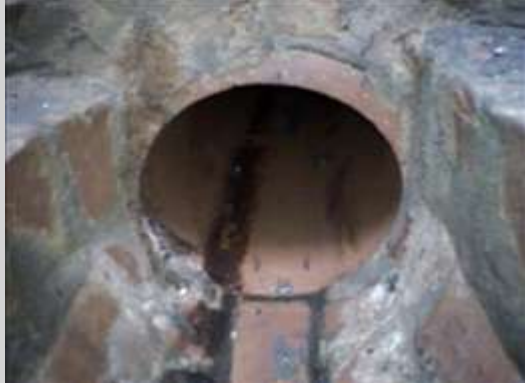
12 O'Clock Outflow

8 in. Circular Gravity Sewer
Pipe Out @ 12 O'Clock

Pipe Height: **8.4** (in.) Rod and Bar (Angled)
Pipe Material: **Clay** ☐ Pipe Lined
Invert Depth: **8.12** (ft.) Flow Characteristics: **Fast**
Deposits: ☒ None ☐ Mud ☐ Sludge ☐ Debris ☐ Grease
Silt Depth: (in.) Deposits Extent:
Infiltration: **None** Pipe Seal Cond: **Sound**

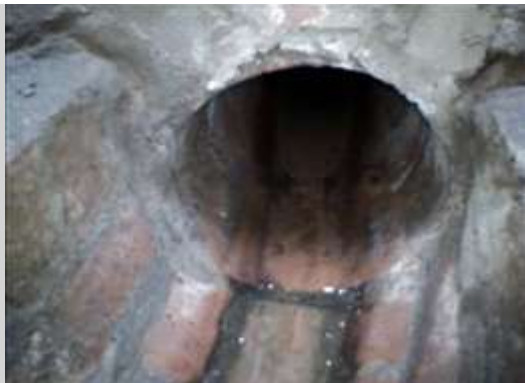
3 O'Clock Inflow

8 in. Circular Gravity Sewer
Pipe In @ 3 O'Clock

Pipe Height: **8.4** (in.) Rod and Bar (Angled)
Pipe Material: **Clay** ☐ Pipe Lined
Invert Depth: **7.86** (ft.) Flow Characteristics: **Fast**
Deposits: ☒ None ☐ Mud ☐ Sludge ☐ Debris ☐ Grease
Silt Depth: (in.) Deposits Extent:
Infiltration: **None** Pipe Seal Cond: **Sound**
